Limited Visual Dam Safety Inspection Summary Report

HI - 00136

Waikoloa 50 MG Reservoir 3

May 2006

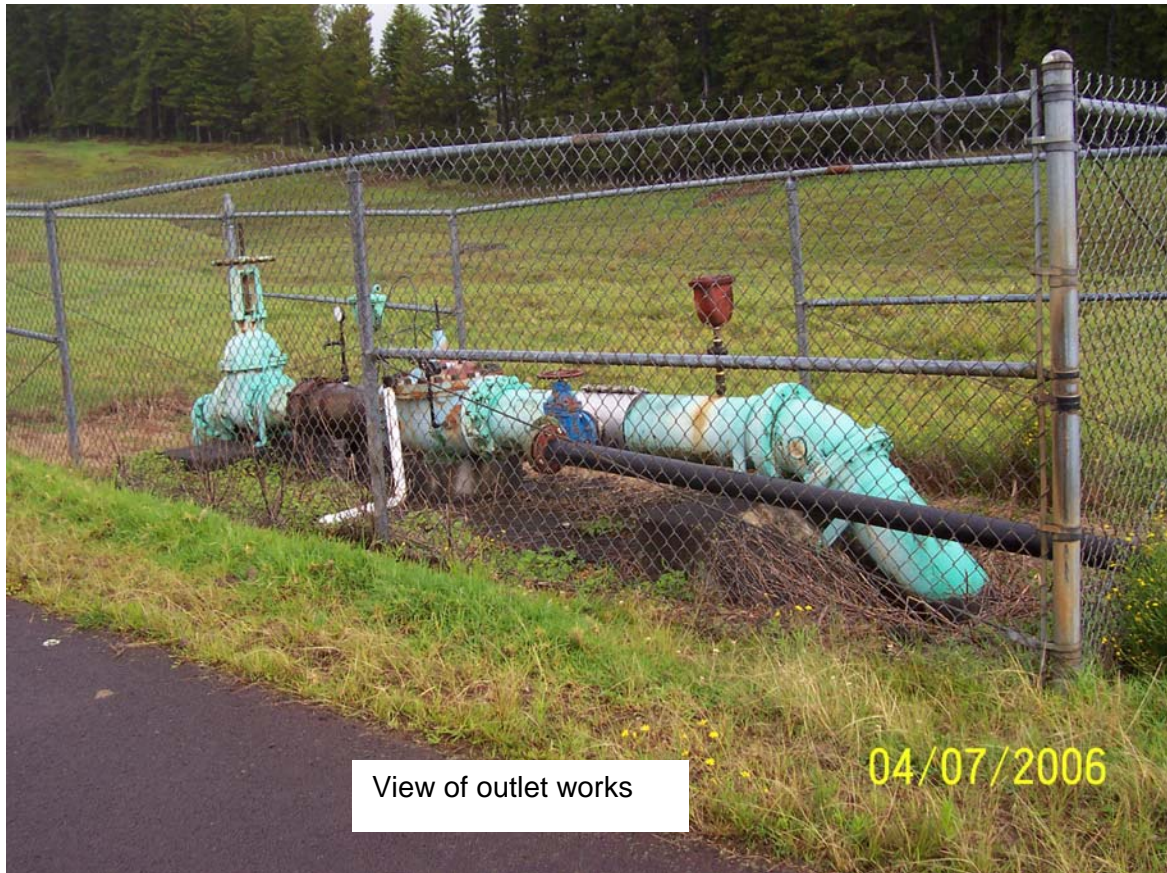
Not inspected in detail, not tested. The outlet works was controlled via a gate valve on the downstream side of the dam. Seepage was not observed flowing near the exit of the outlet works from the dam.

View of outlet works

- a. The outlet works were not inspected.
- b. The outlet works were not tested.
- c. The outlet works appeared to be in satisfactory condition, no corrective actions are required at this time.
